# Prediction of flexural behavior of Artificially time dependent corroded steel beam

## Phân tích ứng xử của dầm ăn mòn nhân tạo theo thời gian

<sup>1</sup>Department of Civil Engineering, University of Technology and Education Ho Chi Minh City,

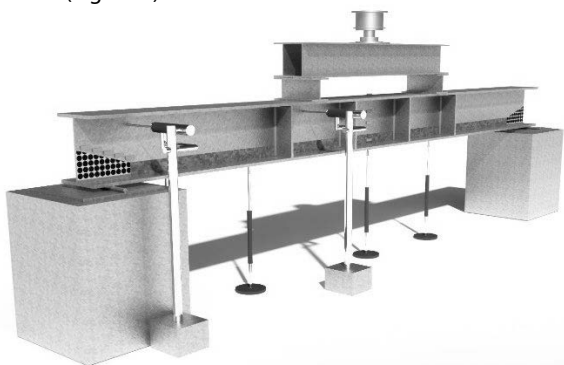
Figure 5. Experimental set up model

After processing, the specimen is put into the experiment that the 4-point inflection model is applied. Based on the conditions in the laboratory and references from previous studies, the experimental model is presented in detail in (Figure 5). In which:

- LVDT1, LVDT2, LVDT3, LVDT4: For measuring beam deflection, thereby building a relationship between force and displacement. This LVDT has a base placed on the foundation, the top part is in contact with the bottom of the steel beam

- LVDT5, LVDT6: For the purpose of recording the horizontal displacement of steel beams, thereby building a relationship between force and displacement. This LVDT has a base placed on the foundation, the top part is in contact with the steel beam web

- Strain Gauges (SG) SG1, SG2, SG3, SG4, SG5, SG6, SG7, SG8, SG9, SG10 are SHOWA brand Strain Gauges, type N11-FA-10-120-11, with gauge length 10mm, designed Pasted on the wings and web of the steel beam, to record the deformation of the steel beam when subjected to load

- Load cell is used to record force values during testing.
- Data recording device - Data Logger, used to record the results of force, LVDT, SG
- All measuring equipment is installed, checked, and calibrated carefully before conducting the experiment. Experimental data is automatically recorded by the computer system with a frequency of 1 time/s.

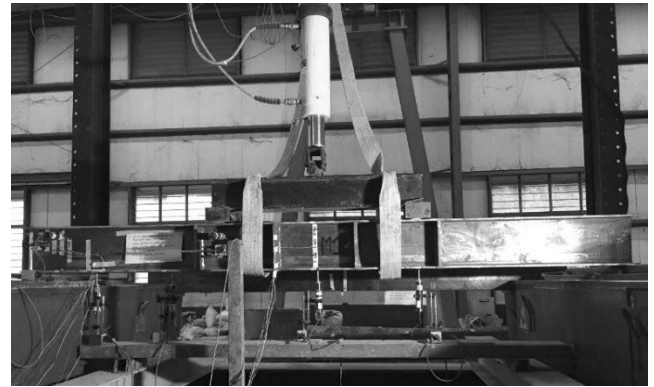
Figure 6. Experimental set up

The process of installing LVTD and strain gauges (SG) on beams is shown in (Figure 6).

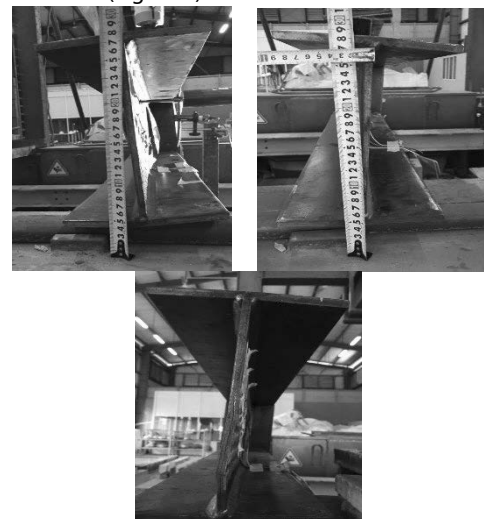
Figure 7. Failure mode of specimens M1, M2, M3

At the end of the destructive test of all three specimens, it was observed that the failure occurred due to instability at the beam end. This is appropriate because the corrosion level at the beam end position is large, so the cross-section is easily damaged at the beam end in (Figure 7).

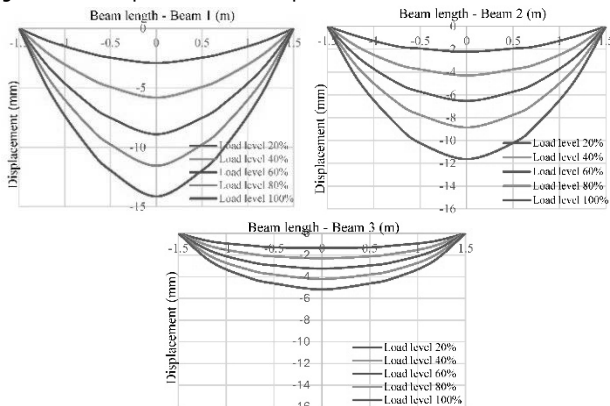
Figure 9. Load levels–deflection relationships

Figure 9 shows that the deflection of the beam changes with each load level, and the displacement increases steadily with each load level. This can explain that the beam still works in an elastic state, but due to corroded cross-section, the structure is damaged in the form of instability.

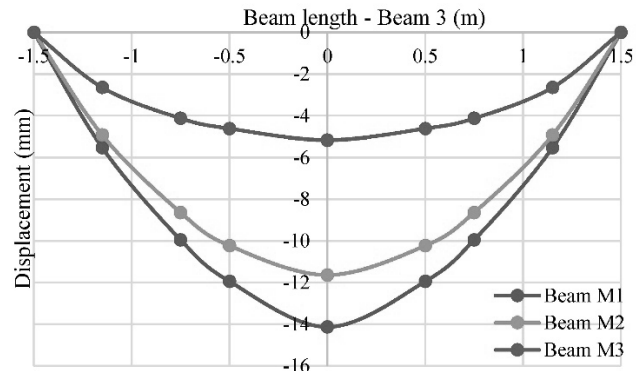
Figure 11. Comparison of maximum load vs. deflection at mid-span curves of beams M1, M2, and M3

The deflection decreases with increasing corrosion level. At 100% load level in the middle of beam LVDT3, the deflection of specimen M1 is larger than specimen M3, the results are shown in (Table 3).

The force-deflection relationship chart at measurement locations LVDT1 to LVDT4 in (Figure 10) and (Figure 11) shows the reasonableness of the corrosion effect on the performance of steel beams. To achieve the same deflection value, it is necessary to Beam M1 must use a larger load than beams M2 and M3.

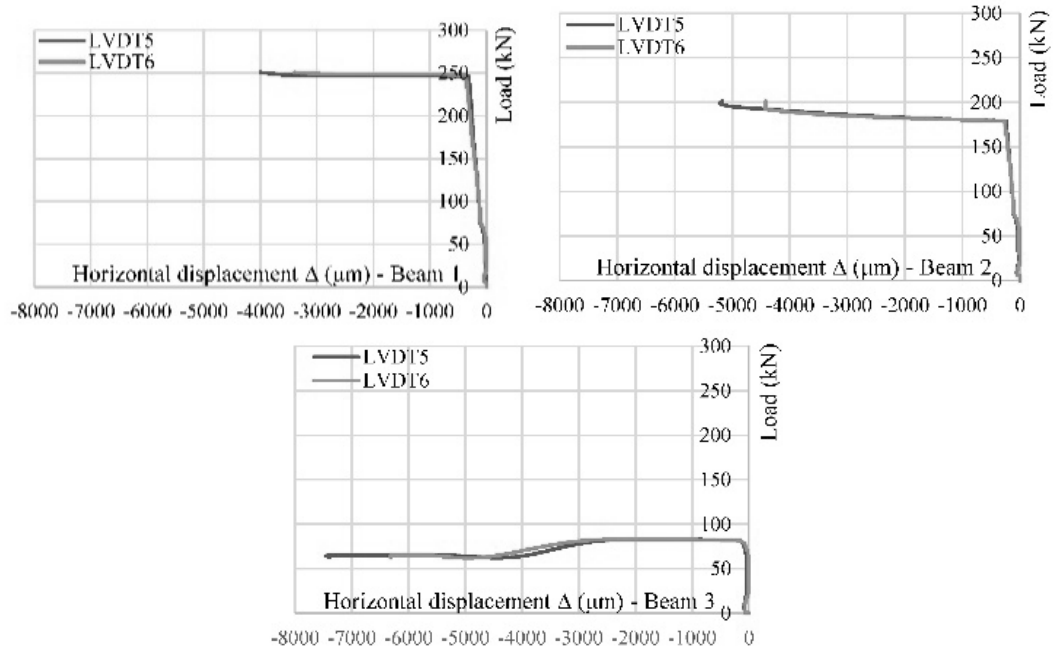
Figure 12. Load - horizontal displacement relationships

The stability of the beam is investigated using LVDT5 and LVDT6, the assessment is through the relationship chart between force - horizontal displacement in (Figure 12). Thereby, the analysis and Evaluations for the behavior of the beam according to stability are drawn by the relationship chart between force - horizontal displacement.

The horizontal displacement of the beam increases with increasing corrosion level. At 100% load level, at LVD15, the horizontal displacement of beam M3 is larger than beams M2 and M1 as shown in (Table 5).
